Handheld real-time fluorescence imaging of bacteria guides treatment selection and timing of dressing changes in inpatients undergoing negative pressure wound therapy

Rose Raizman, RN-EC, MSc

Scarborough Rouge Hospital System, Toronto, ON, Canada

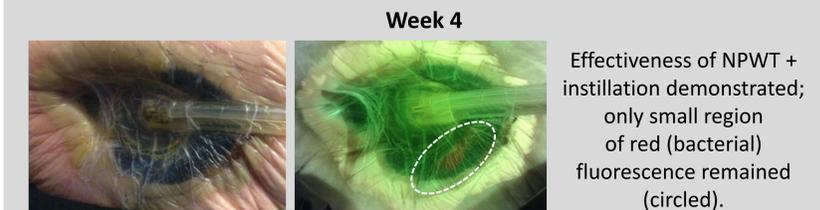
Case 1: Detection of Bioburden Under Sealed Adhesive Prompts Change in Treatment Plan and Expedites Dressing Changes

85-year-old female, deep sacral ulcer. Fluorescence imaging enabled detection of bacterial fluorescence under sealed, optically-transparent (routine) adhesive prior to dressing changes, on foam dressings, within the wound, and on peri-wound tissues.

Red fluorescence (circles) prompted additional cleaning of peri-wound region and maintenance of this patient on NPWT + instillation, rather than the planned return to standard NPWT.

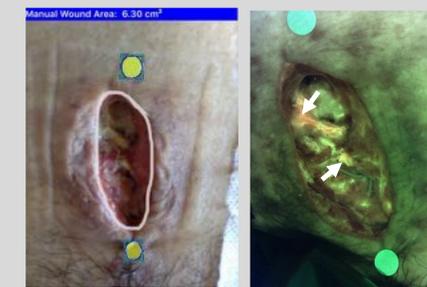
Case 3: Real-time Bacterial Fluorescence Detection Guides Selection of NPWT with Instillation of Wound Cleansers

65-year-old male with abdominal surgical wound (6.30 cm²). Fluorescence images taken prior to initiation of NPWT revealed significant bioburden, guiding the clinician's selection of NPWT + instillation of wound cleaning fluids.

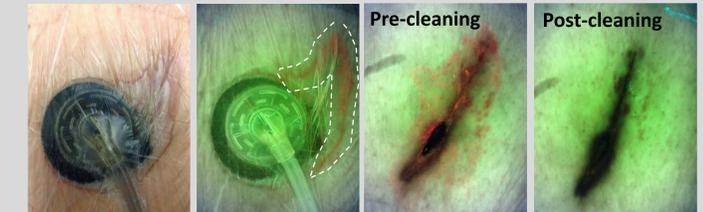
Case 4: Fluorescence Images Guide Extent and Location of Wound Cleaning at Scheduled NPWT Dressing Change

58-year-old male with appendectomy abscess undergoing NPWT. Red fluorescence observed under adhesive (circled) and on wound. Fluorescence guided the extent and location of wound cleaning at this dressing change.
