Efficacy of a bacterial fluorescence imaging device in an outpatient wound care clinic: a pilot study

Objective: Subsurface bacterial burden can be missed during standard wound examination protocols. The real-time bacterial fluorescence imaging device, MolecuLight i:X, visualises the presence of potentially harmful levels of bacteria through endogenous autofluorescence, without the need for contrast agents or contact with the patient. The intended use of the imaging device is to assist with the management of patients with wounds by enabling real-time visualisation of potentially harmful bacteria. The aim of this study was to establish the accuracy of the wound imaging device at detecting pathogenic bacteria in wounds.

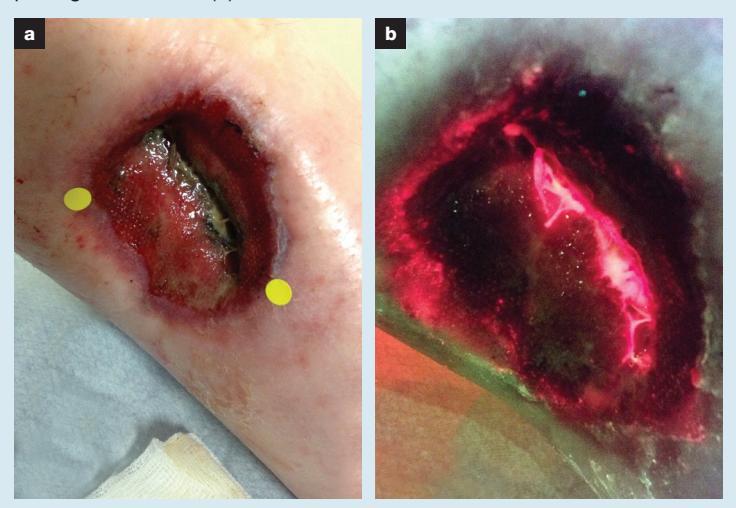
Fig 1. Case 1, a 67-year-old male with a chronic lower leg wound secondary to a failed STSG (size: 5.4x4.1cm) of eight weeks' duration. White light image of a wound on the lower limb (**a**); autofluorescent image of wound showing red fluorescence suggesting presence of potentially pathogenic bacteria (**b**)

A 67-year-old male with a chronic lower leg wound secondary to a failed split-thickness skin graft (STSG; size: 5.4x4.1cm) of eight weeks' duration. This patient did not demonstrate the typical features of wound infection. Fig 1a demonstrates the white-light image captured by the wound imaging device. The yellow stickers allow the camera to correctly adjust its distance calculator. Fig 1b demonstrates the areas of red fluorescence suggesting the presence of potentially pathogenic bacteria; four wound swabs taken from the targeted area confirmed the presence of *Staphylococcus aureus*.

Our case studies demonstrate various aspects of the devices practicalities. Case 1 demonstrates the need for objective wound swab sampling methods. The bacterial fluorescence imaging allowed targeted sampling of the wound bed, which may otherwise have led to a false negative swab result. Case 2 exhibits determination of the presence of *Pseudomonas aeruginosa*. We found the device's positive predictive value of detecting Pseudomonas aeruginosa particularly useful in the plastic surgery clinic, due to this bacterium's potential to contaminate skin grafts, resulting in partial or complete graft loss. The same is also applicable for *Staphylococcus* aureus which was the most common bacteria detected in our study.¹⁶ The wound measuring tools used in Case 3 were useful in documenting the progression or regression of chronic wounds. Its measurements were instant and accurate. There were two false positive cases in our study (Table 3). The first was a 69-year old male, day 12 post-STSG to the lateral aspect of the leg. The second case was a 49-year old female, day eight post-STSG to the leg. Both were red FL-positive but grew no microorganism in the swab culture. This is likely due to poor swabbing technique. However, the fluorescent light may be identifying subsurface fluorescent bacteria that swabs fail to. This may be overcome with wound bed curettage.

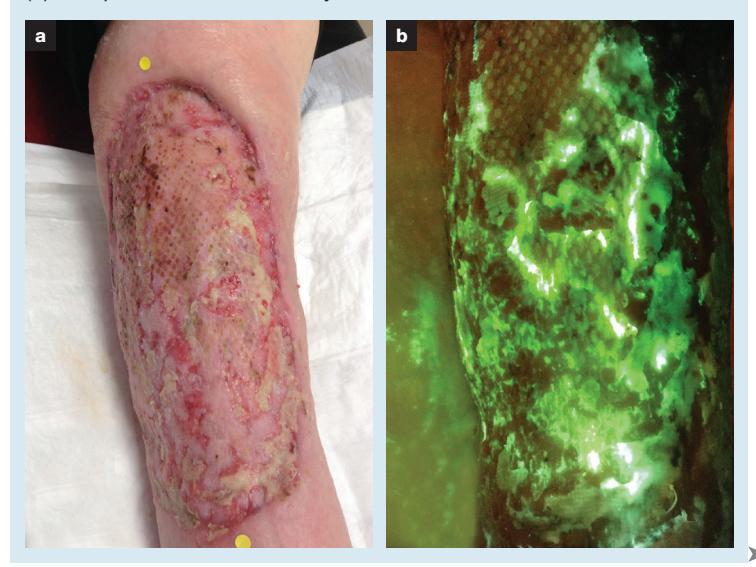
Fig 2. Case 2, a 58-year-old male, 12 days after a split-thickness skin graft (STSG) to the lower limb (24.3x6.2cm). White light image of the STSG (**a**); autofluorescent imaging demonstrating cyan in the wound bed (**b**). The patient was immediately started on antibiotics

A 58-year-old male, 12 days post-STSG to the lower limb (size: 24.3x6.2cm). The wound bed was malodourous but did not demonstrate other typical signs of infection. Autofluorescent imaging, shown in Fig 2b, clearly demonstrates cyan fluorescence. The patient was immediately started on appropriate antibiotics for *Pseudomonas aeruginosa*. After four days, wound swab results formally demonstrated *Pseudomonas aeruginosa* in three separate swabs.

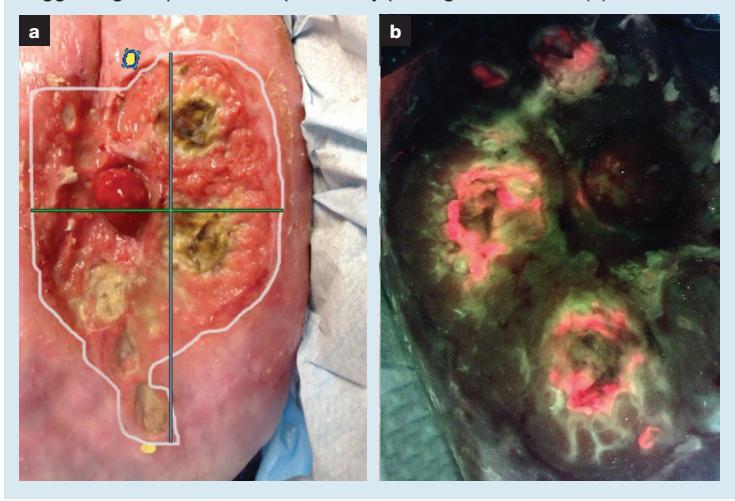
Fig 3. Case 3, a 61-year-old female with a chronic sacral pressure ulcer (PU) of nine months' duration (size: 6.5x5.8cm). White light image of PU (**a**); autofluorescent imaging of PU demonstrating red fluorescence suggesting the presence of potentially pathogenic bacteria (**b**)

A 61-year-old female with a chronic sacral pressure ulcer (PU) of nine months' duration (size: 6.5x5.8cm). Fig 3 demonstrates the built-in wound bed size estimator in the camera of the device. This was used to document wound progression by nursing staff. This chronic sacral PU was regressing over a number of weeks. The autofluorescent imaging was used after bedside debridement. Red fluorescence was identified, indicating the presence of potentially pathogenic bacteria. Wound swabs confirmed the presence of *Staphylococcus aureus*, and the patient was commenced on antibiotics and appropriate dressings to decrease the bacterial load.
