# The use of the MolecuLight bacterial camera in the management of bacterial load in burn patients

Lt Col SLA Jeffery, RAMC<sup>1,2</sup> and Emily Blumenthal<sup>1</sup>

<sup>1</sup>Queen Elizabeth Hospital (Birmingham, United Kingdom), and <sup>2</sup>The Royal Centre for Defence Medicine (United Kingdom)

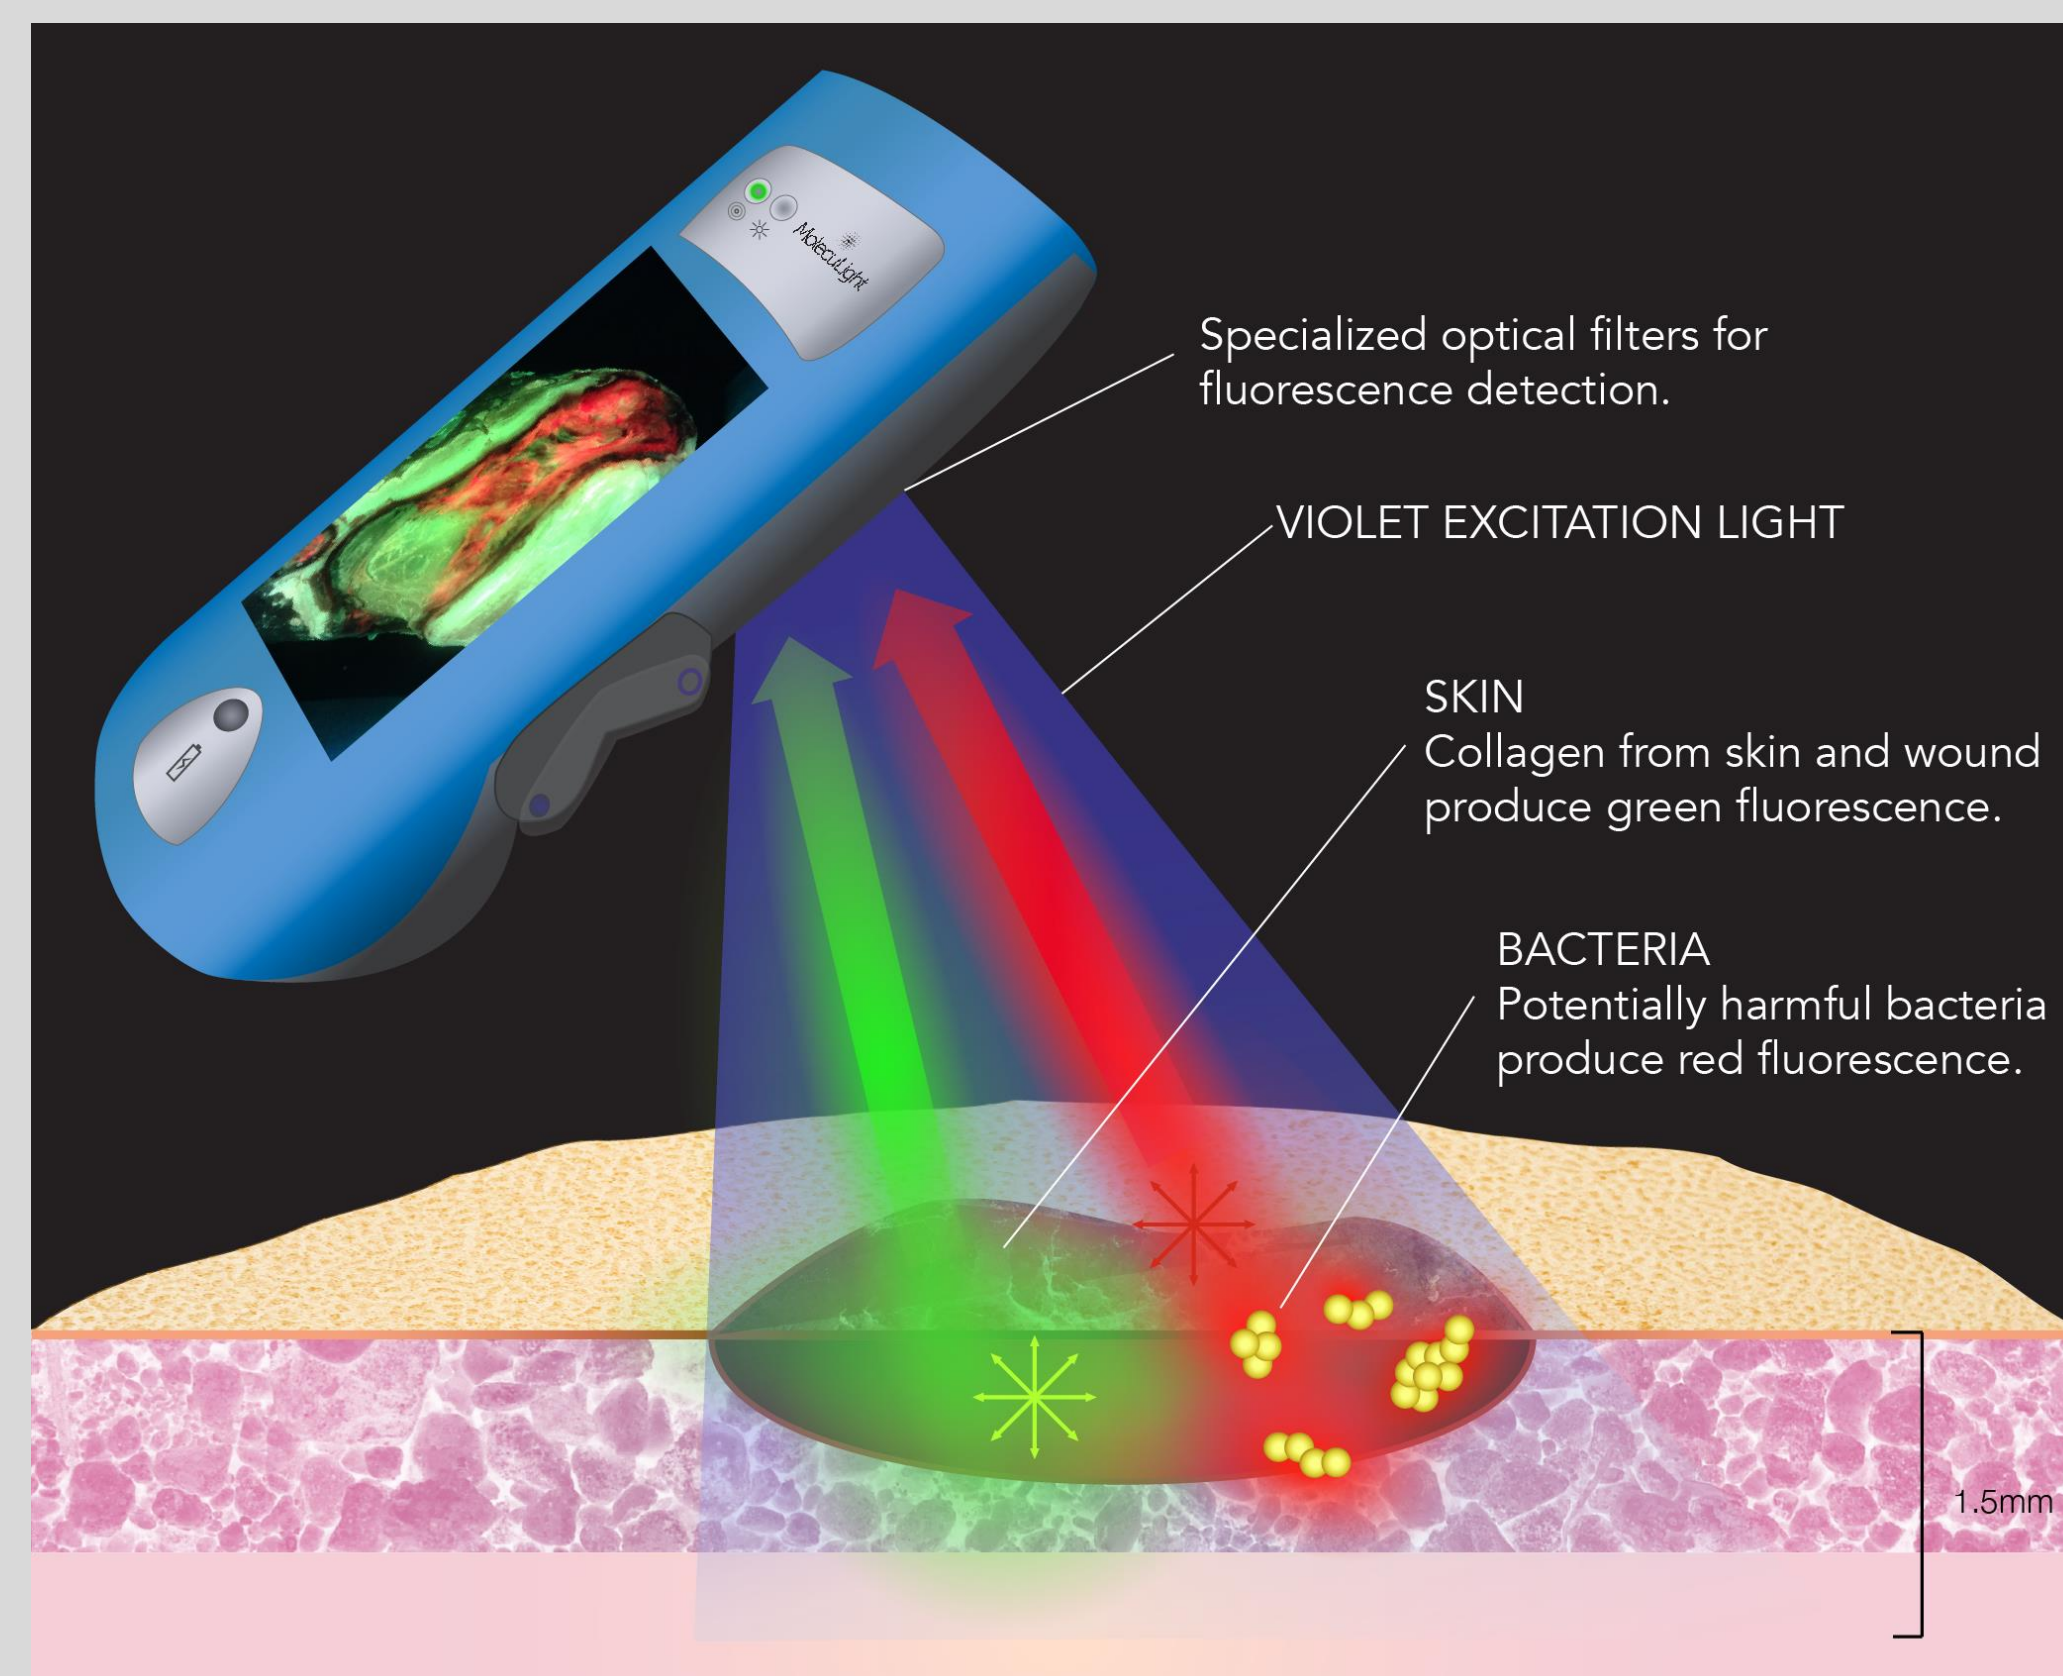
- When excited by 405 nm violet light, tissues fluoresce green while bacteria fluoresce red (porphyrin-producers) or cyan (pyoverdine-producing *Pseudomonas aeruginosa*).
- This enables real-time, point-of-care detection and localization of bioburden ( $\geq 10^4$  CFU/g) within and around wounds<sup>2-5</sup>.

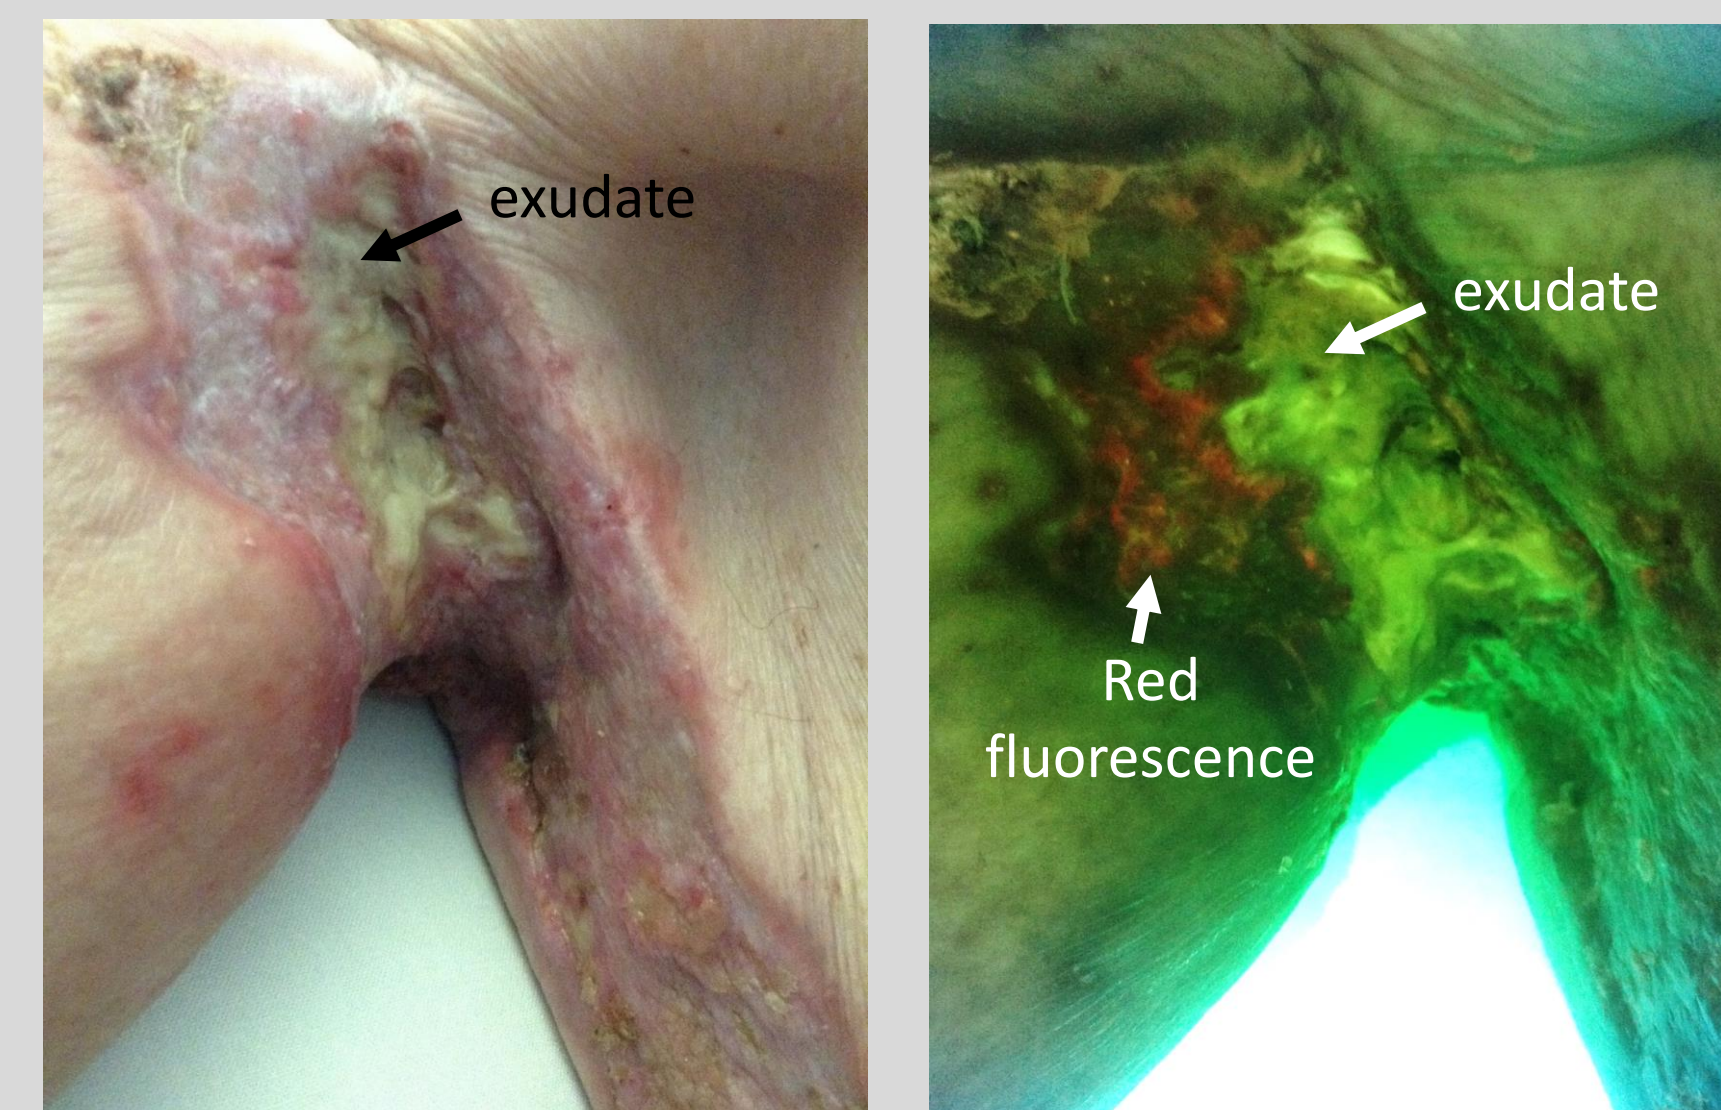
Standard Imaging Mode      Fluorescence Imaging Mode

85-year-old male suffered deep dermal and full thickness contact burns to the right axilla, forearm, and scapula. Swabs taken from exudate in days prior to imaging were negative. Fluorescence images revealed red fluorescence on outlying tissue, not on exudate, guiding targeted swabbing of the red region.

Swabs confirmed growth of *Staphylococcus aureus* and *E. coli*.

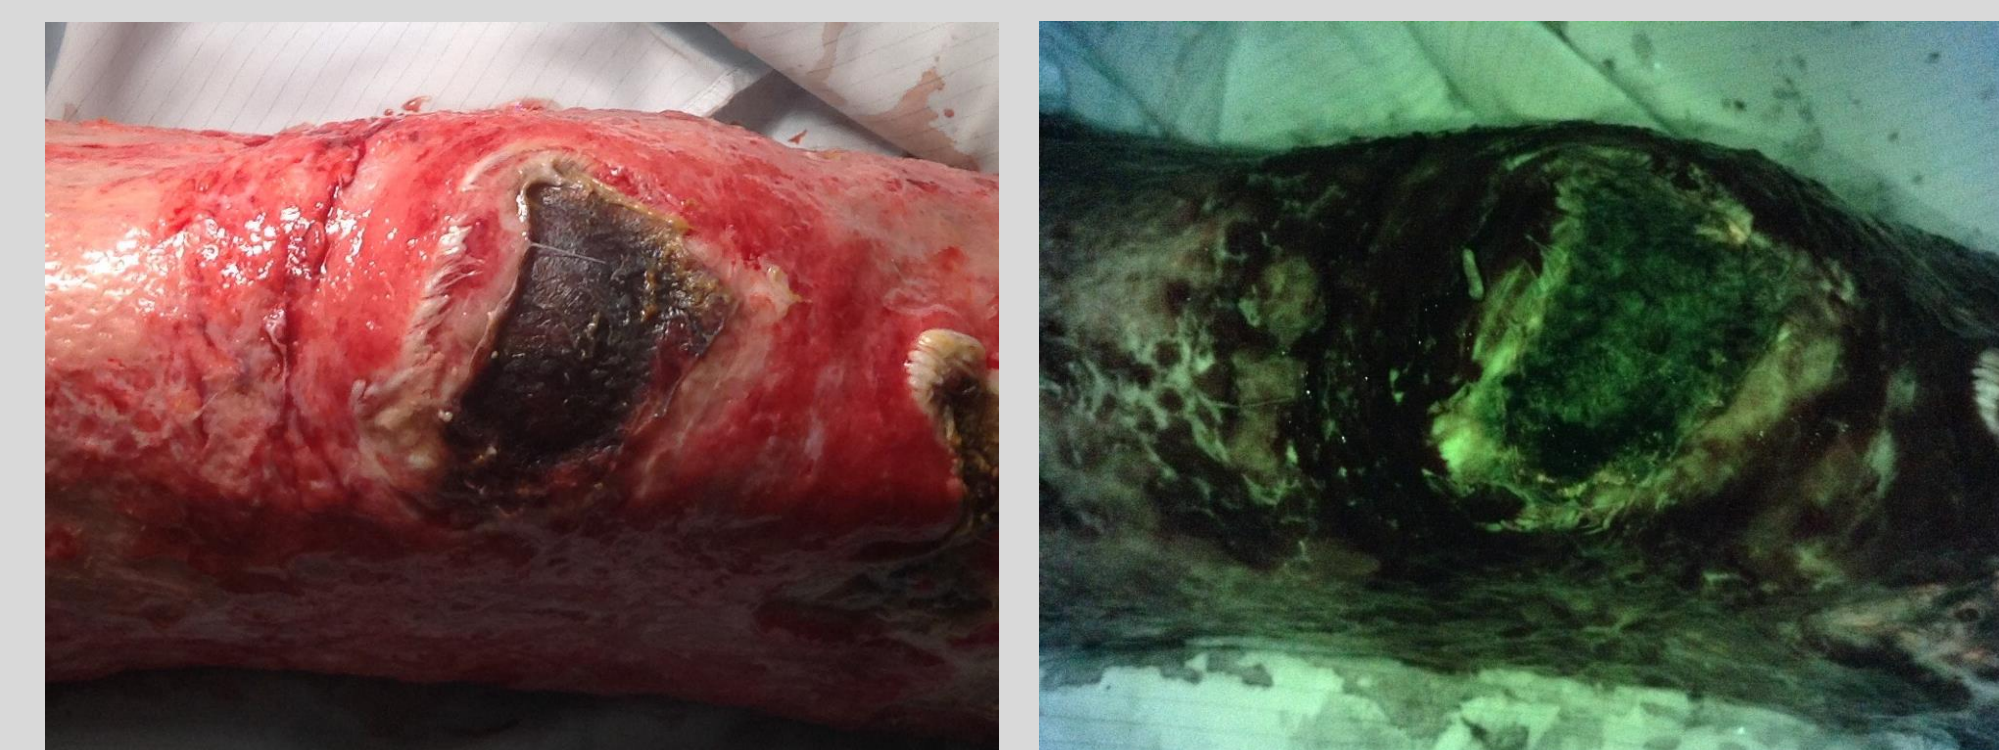
Standard Imaging Mode      Fluorescence Imaging Mode

58-year-old man suffered deep burns down to the bone on right leg. Fluorescence images were acquired to determine whether region was a candidate for skin grafting (contraindicated when bioburden present). No fluorescence signals that would suggest bacterial presence were found.

Swabs confirmed no growth of bacteria.

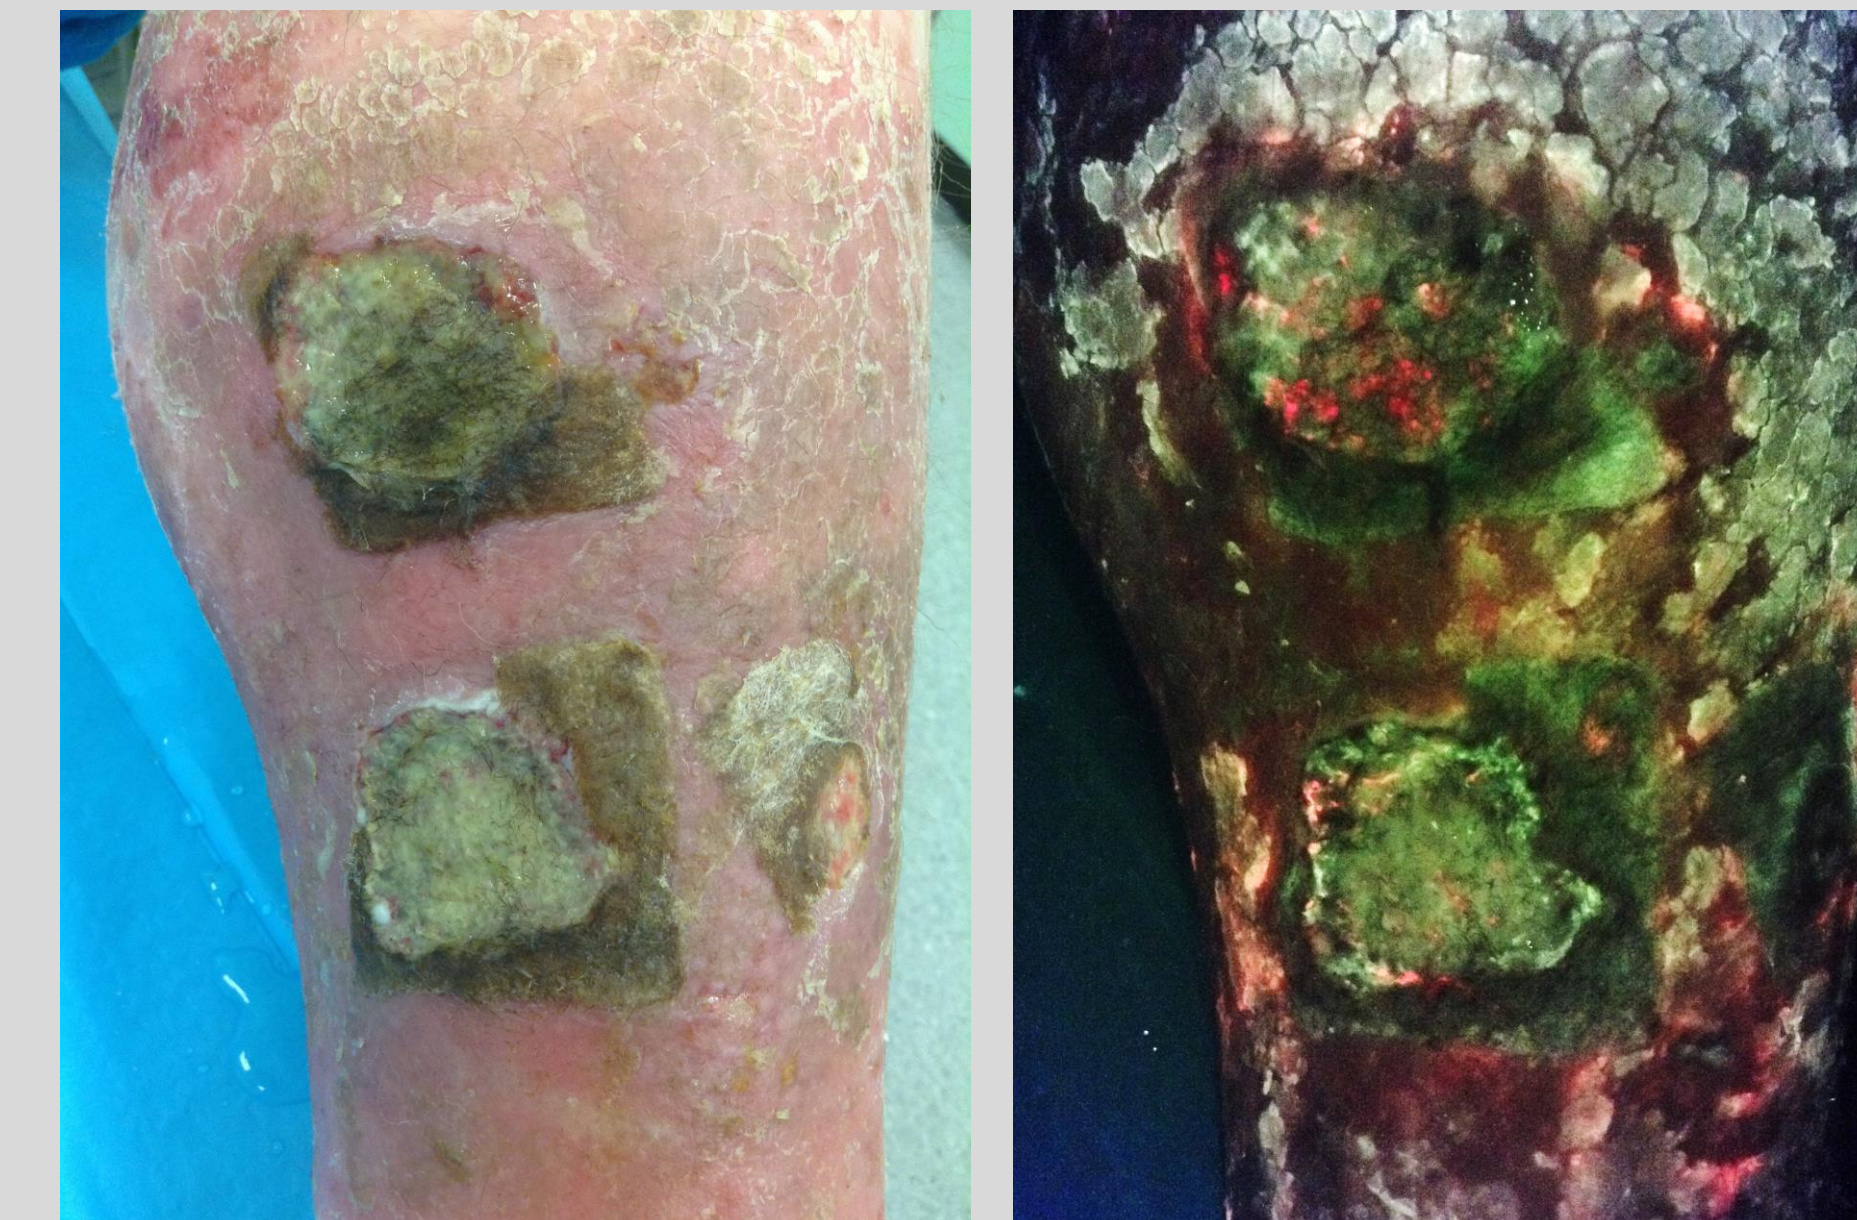
Standard Imaging Mode      Fluorescence Imaging Mode

Male patient spilled battery acid onto left calf, left burns untreated for several weeks. Came to burn unit when leg was swollen, red and foul smelling. Ultrasound revealed deep vein thrombosis. Wound initially treated with antimicrobial scrub and dressing. However, fluorescence images revealing widespread bacterial (red) fluorescence within and around the wounds guided the prescription of a course of antibiotics.

Swabs later confirmed heavy growth of *Staphylococcus aureus*.

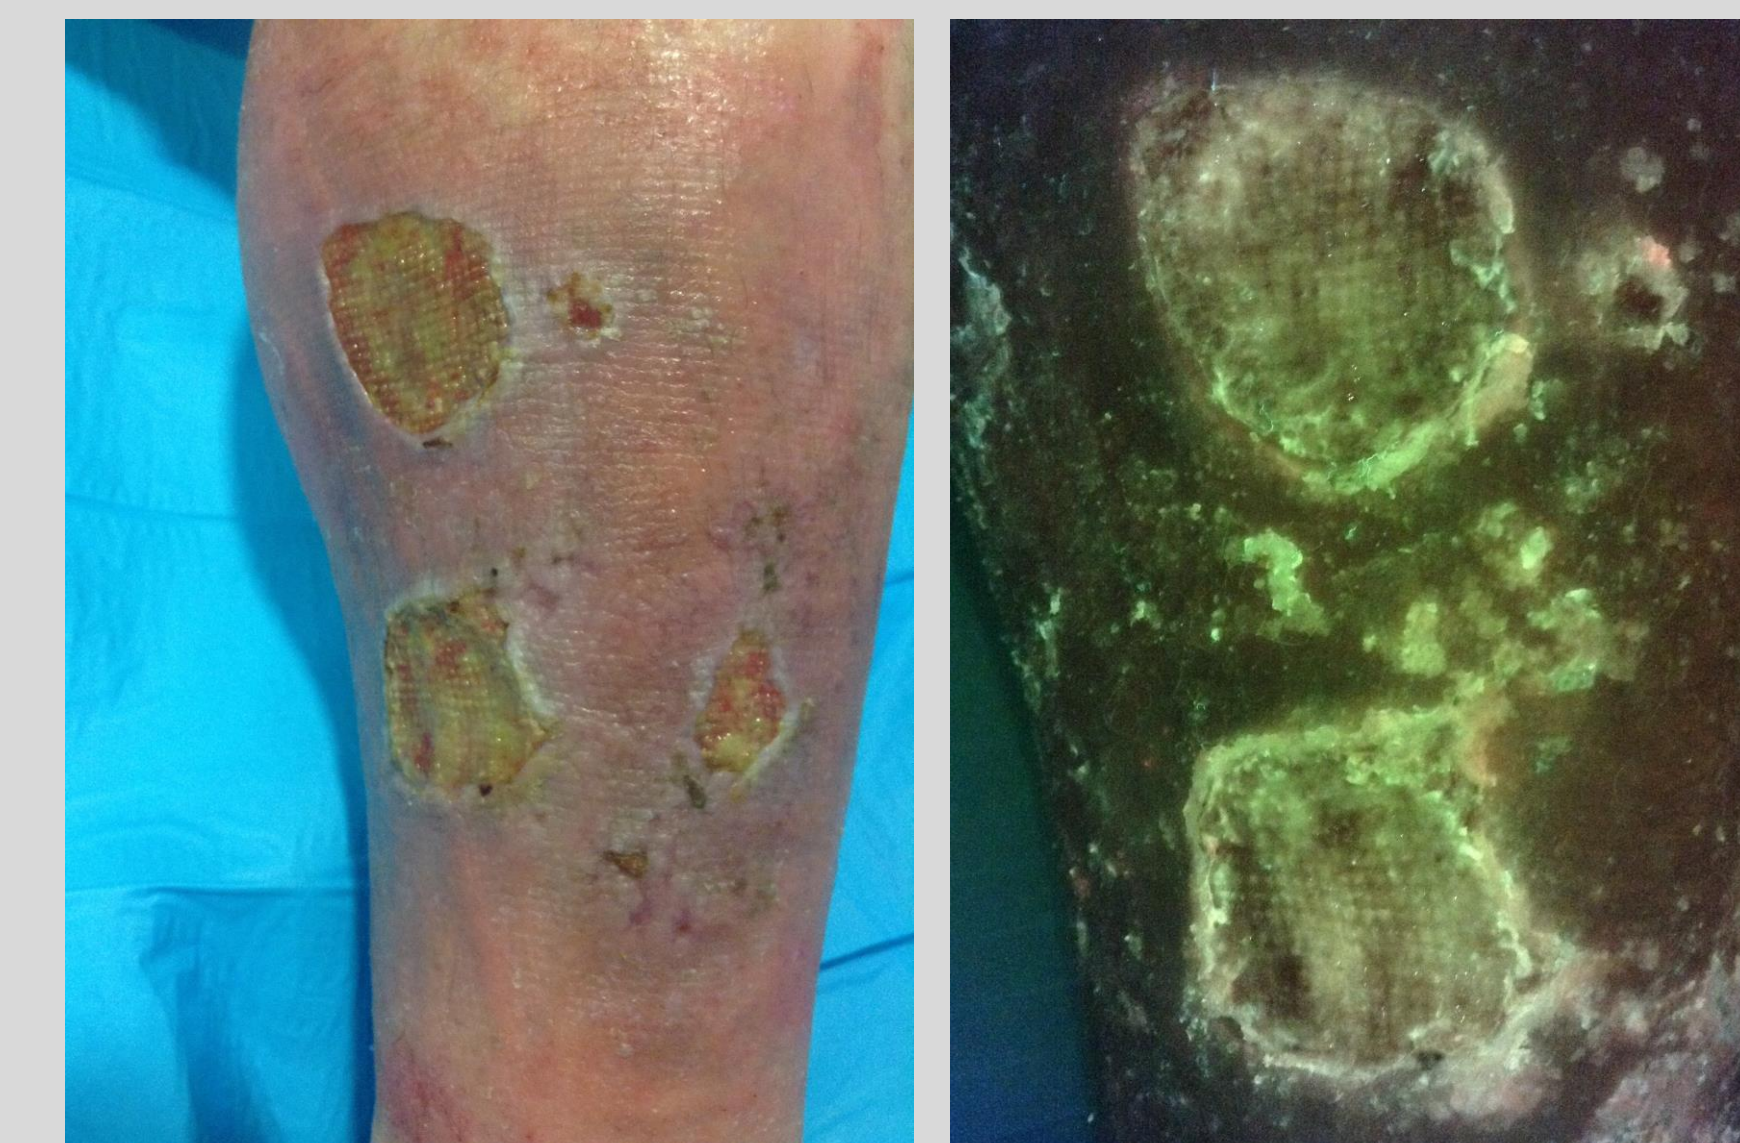
Standard Imaging Mode      Fluorescence Imaging Mode

Subsequent images acquired after three days of prescribed antibiotic demonstrated a dramatic decrease in bacterial (red) fluorescence. The wounds were therefore deemed to be significantly cleaner and no further antibiotics were prescribed. Fluorescence images enabled real-time monitoring of antibiotic treatment effectiveness and avoided time delays associated with microbiological (swab) confirmation.

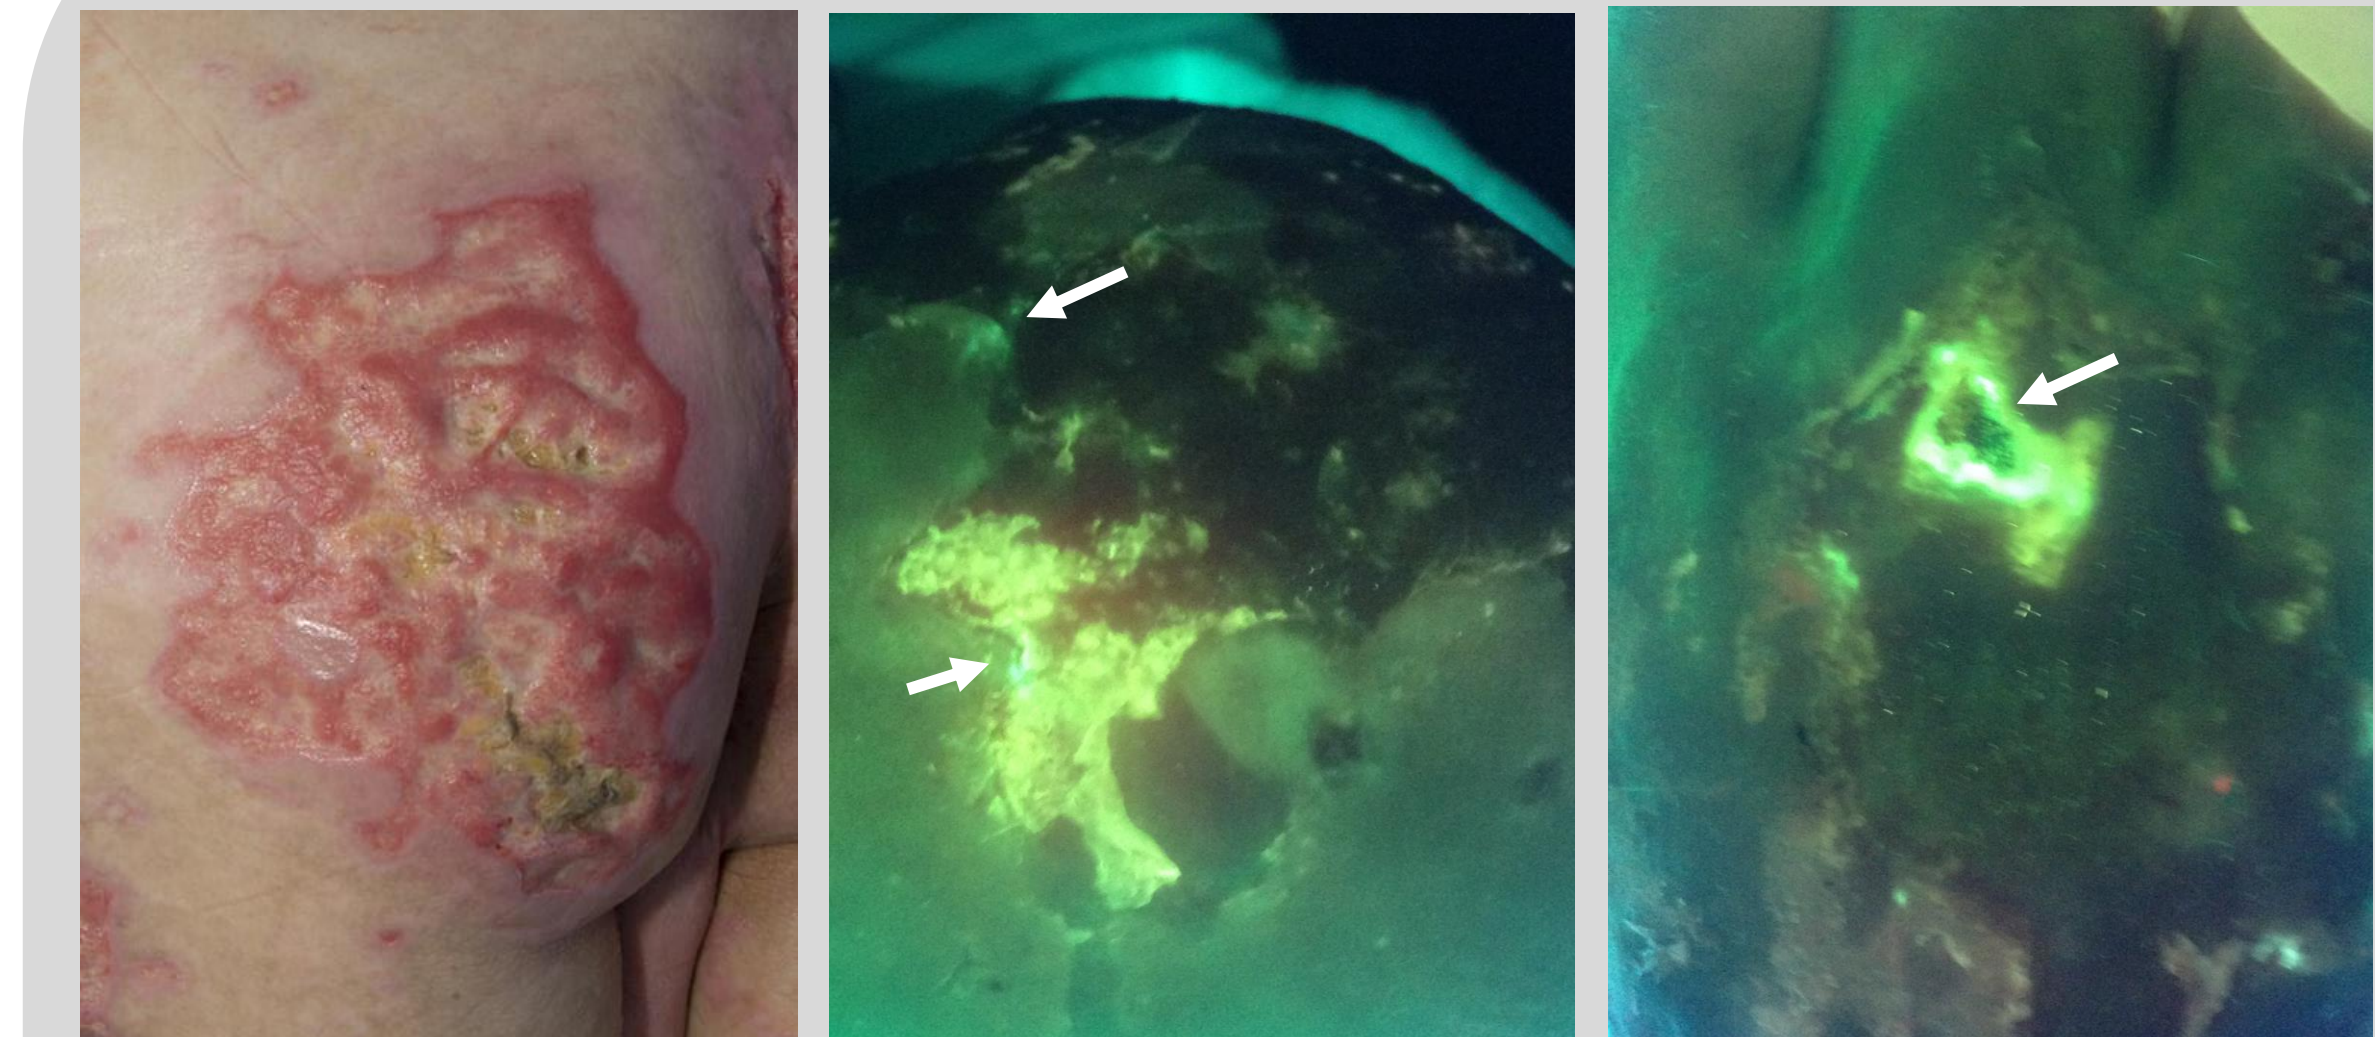
Standard Imaging Mode      Fluorescence Imaging Mode

32-year-old male suffered purpura fulminans following streptococcal septicaemia, affecting 50% of his total body surface area. Fluorescence images revealed small pockets of *P. aeruginosa* colonization (cyan, arrows), enabling swabs to be taken from these specific regions.

Swabs confirmed heavy growth of *Pseudomonas aeruginosa*.
